North Main Watershed Assessment

Introduction

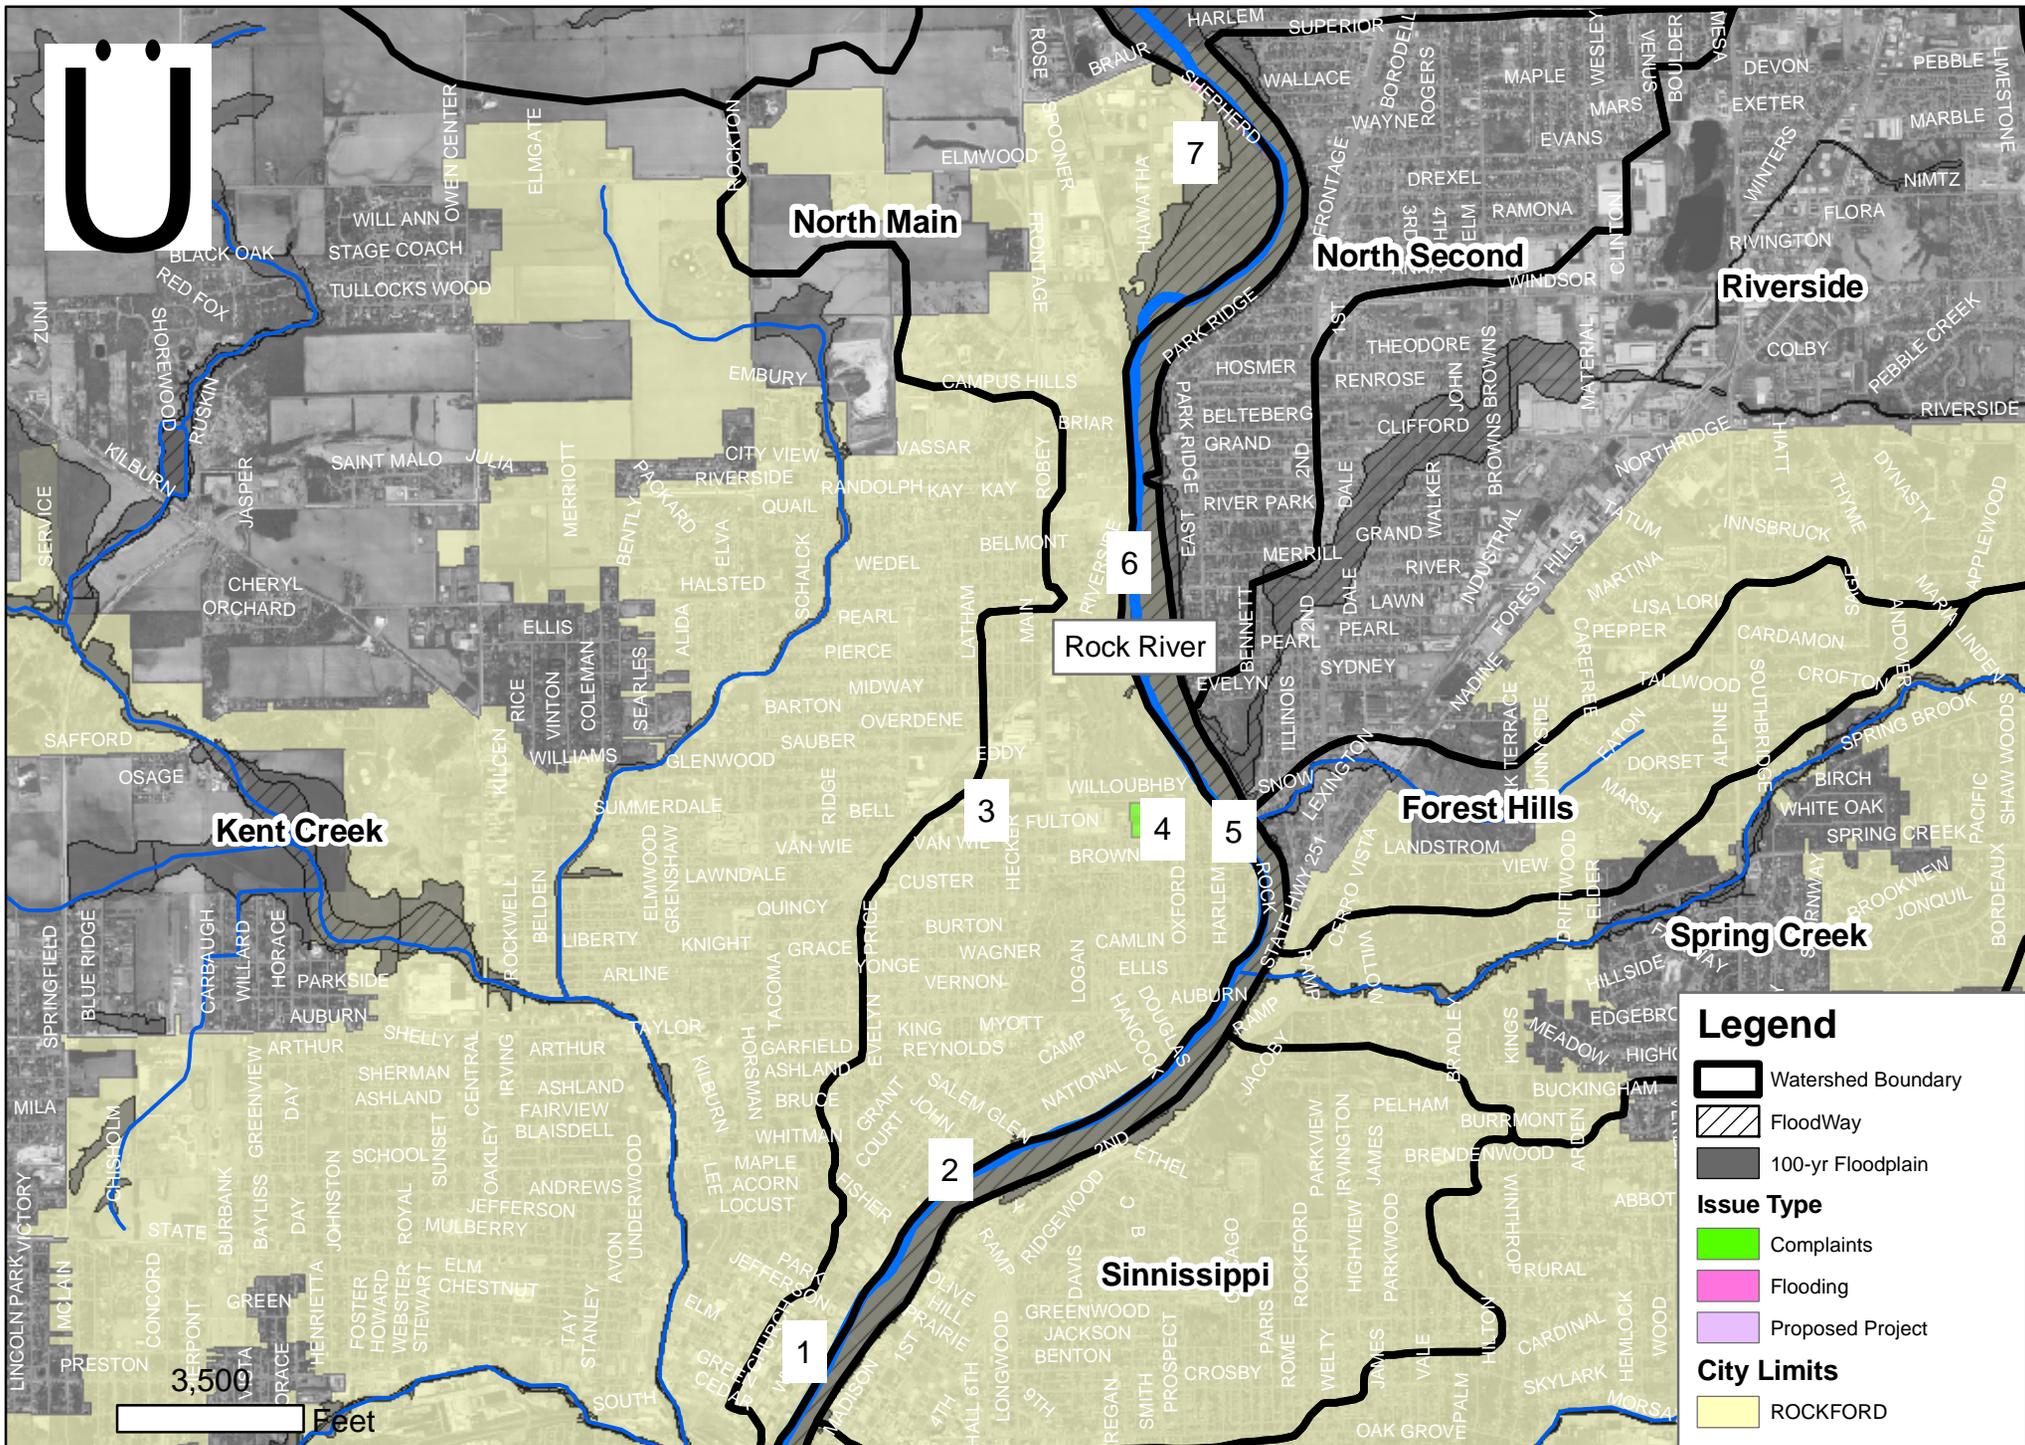
Given the character of the watershed, flooding within North Main is primarily caused by pooling due to wet weather events, and over-bank flooding of the Rock River in the indicated areas on Figure NM-1. As shown in the Figure, the floodplain along the Rock River is very narrow, and along the North Main boundary, it does not enter any developed area, except where it widens, north of Campus Hills, where the Sportscore playing fields are located.

Table NM-1 (on the following page) provides a summary listing of current identified drainage issues and projects within the North Main watershed. The general locations of these issues and projects are shown on Figure NM-1.

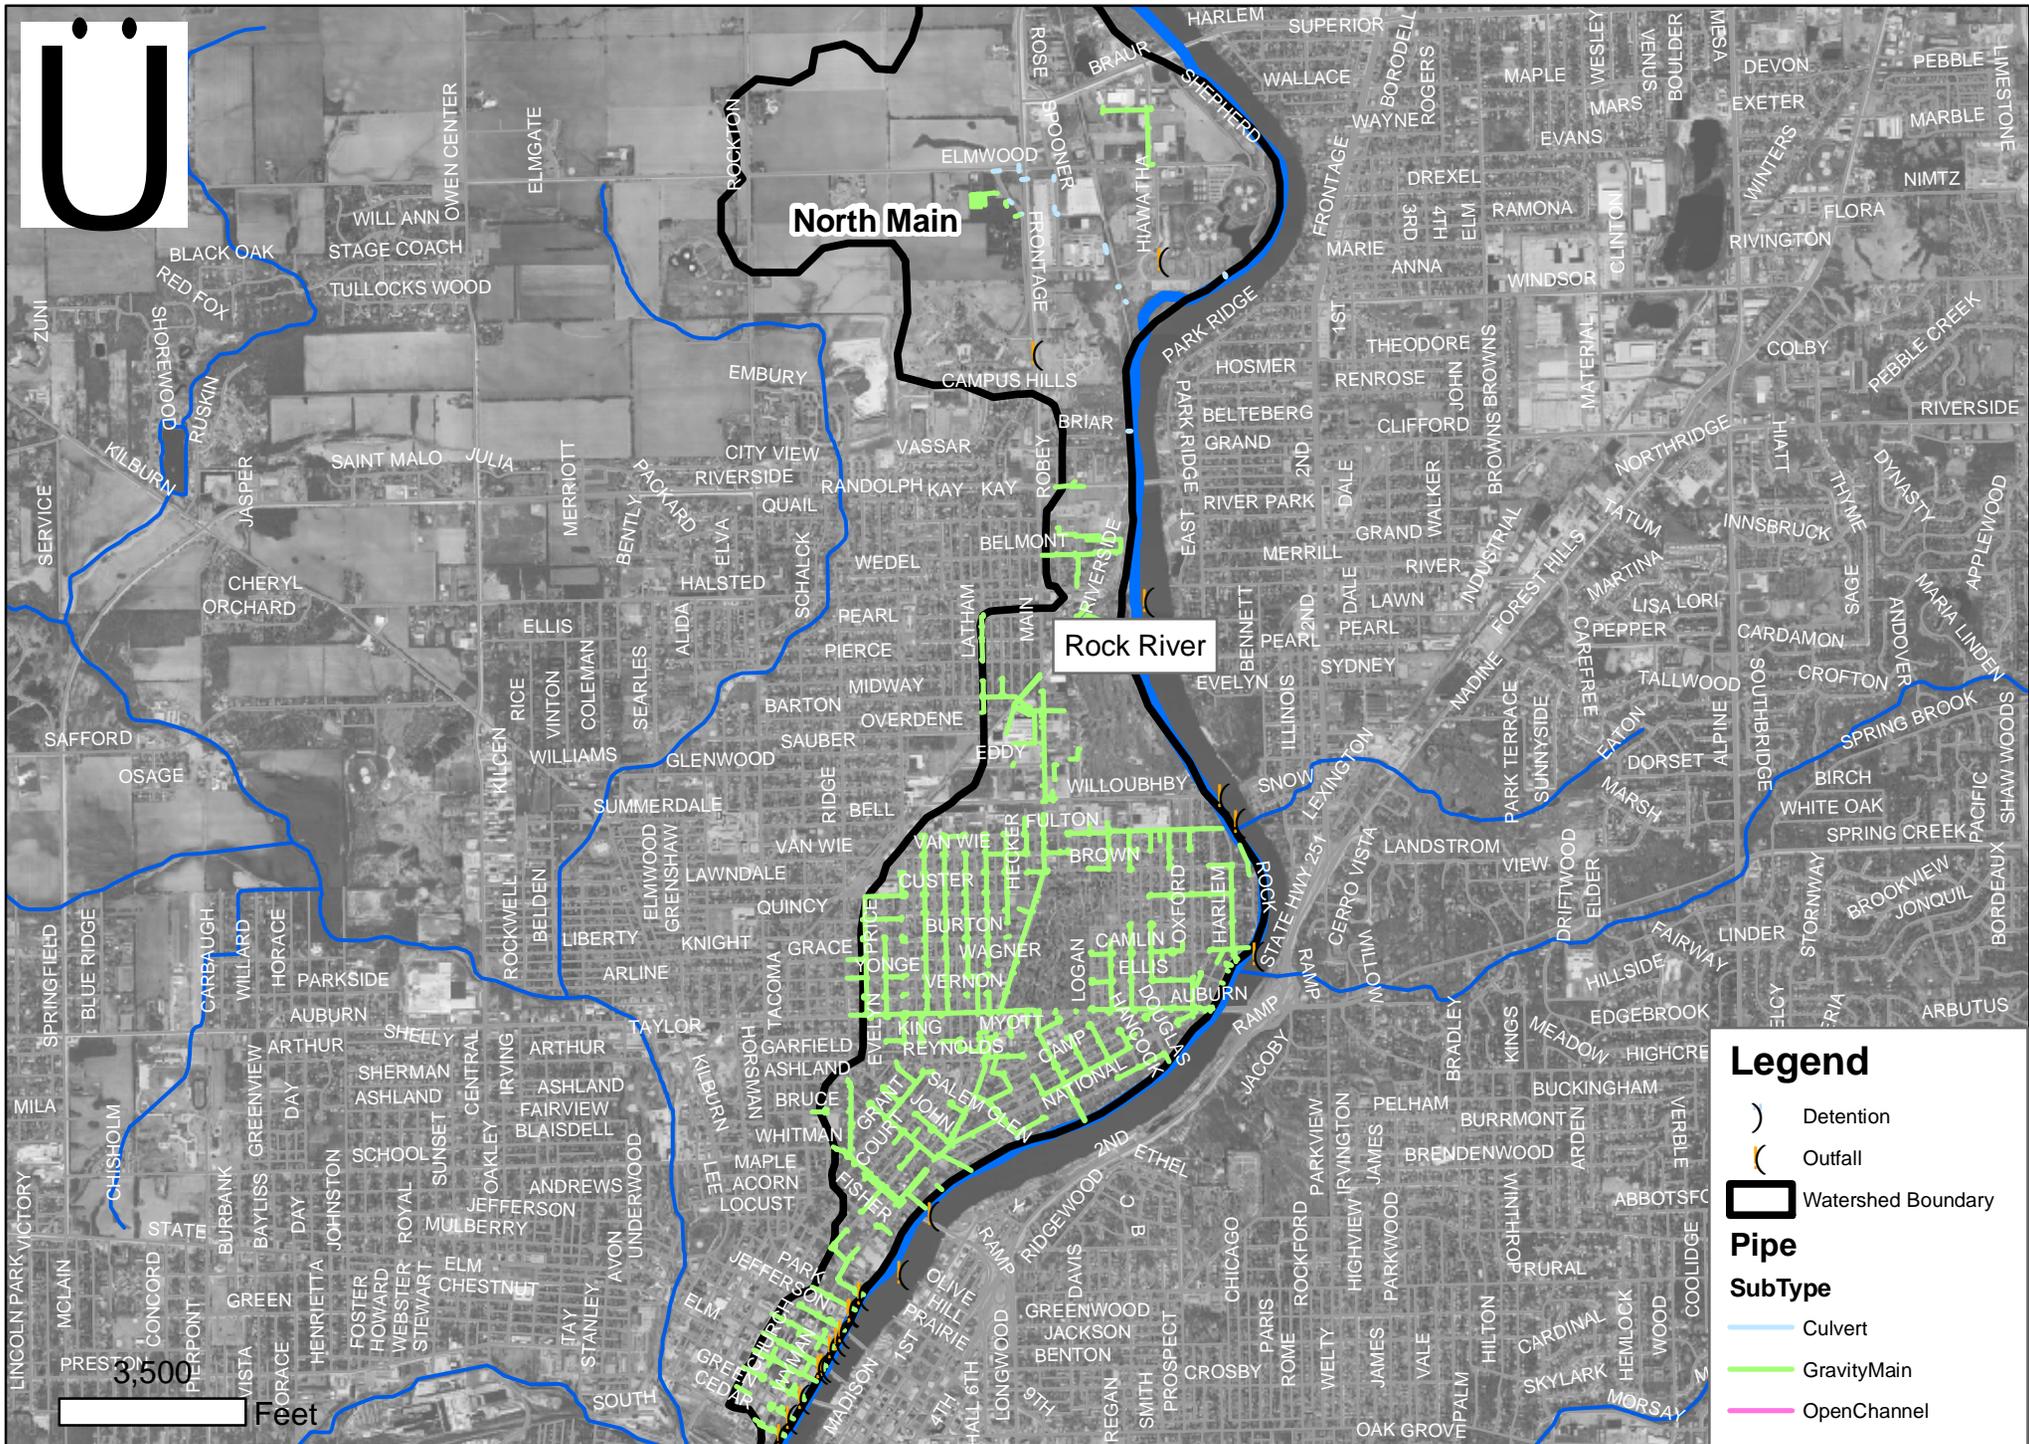
Drainage within the North Main watershed occurs through equal parts surface drainage to the Rock River, and via gravity storm sewer network. The storm sewers and storm sewer outfalls can be seen in Figure NM-2, and are heavily concentrated and complete in the south and central

watershed area which are the urbanized areas. The North Main watershed uses completely surface drainage in the north, rural areas, and has no identified surface detention facilities.
